Property Inspection Report

Client(s): Prospective Buyer(s)
 Property address: 41410 Juniper St Unit 122
 Murrieta CA 92562-9779
 Inspection date: Sunday, November 05, 2017

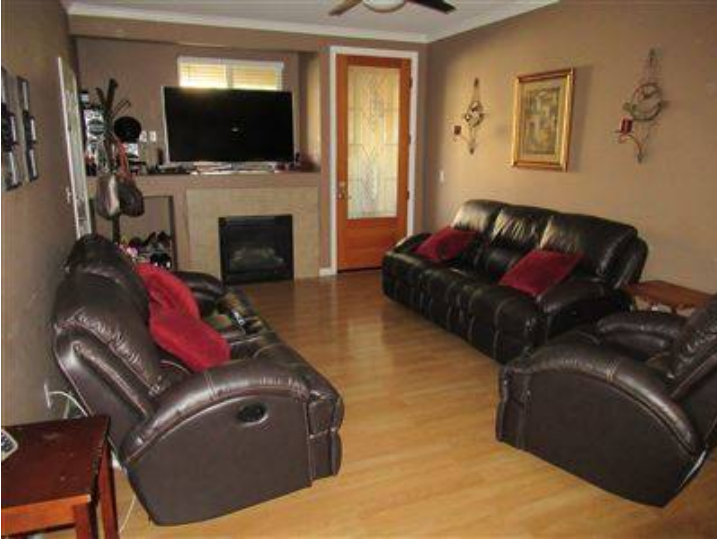
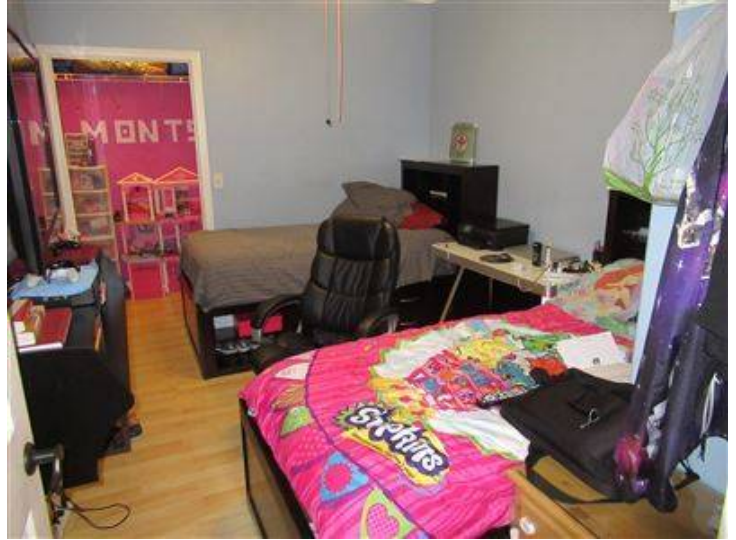
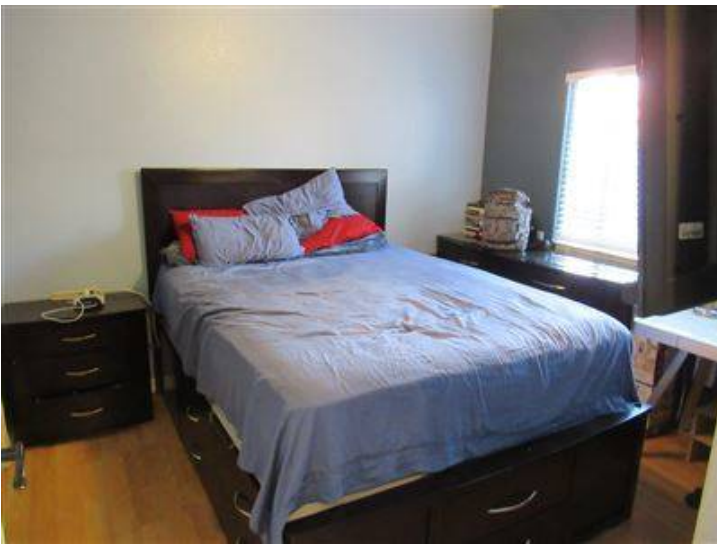
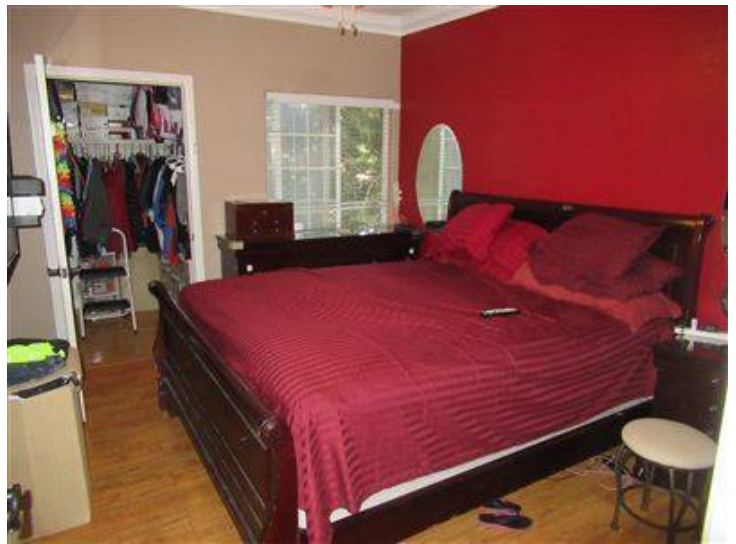
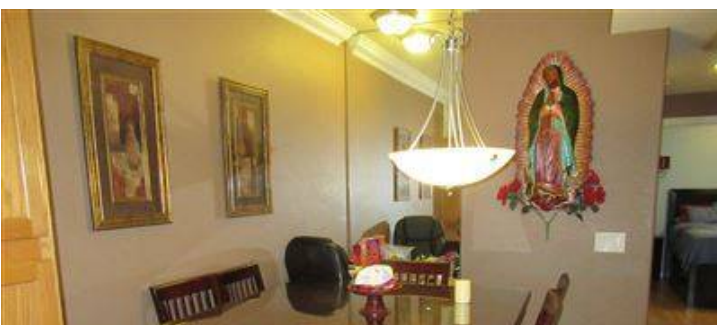
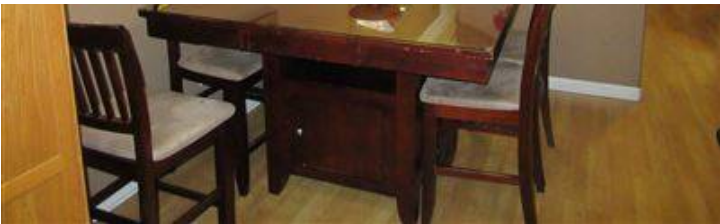
Some areas and items at this property were obscured by furniture and/or stored items. This often includes but is not limited to walls, floors, windows, inside and under cabinets, under sinks, on counter tops, in closets, behind window coverings, under rugs or carpets, and under or behind furniture. Areas around the exterior, under the structure, in the garage and in the attic may also be obscured by stored items. The inspector in general does not move personal belongings, furnishings, carpets or appliances. When furnishings, stored items or debris are present, all areas or items that are obscured, concealed or not readily accessible are excluded from the inspection. The client should be aware that when furnishings, stored items or debris are eventually moved, damage or problems that were not noted during the inspection may be found.

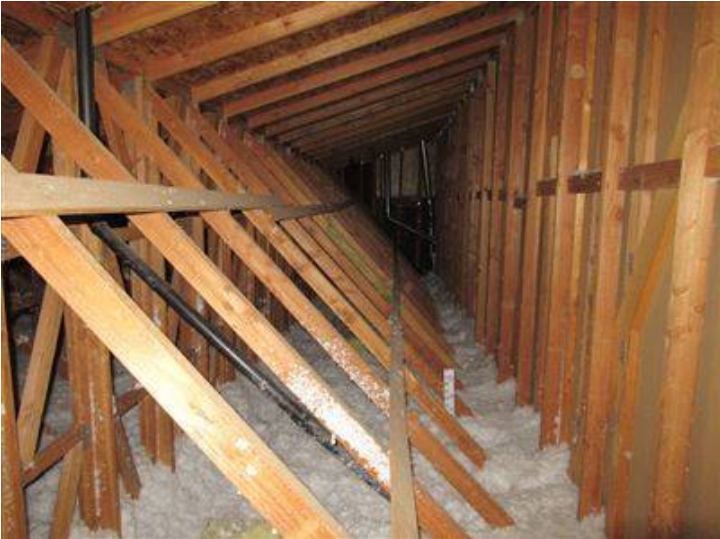
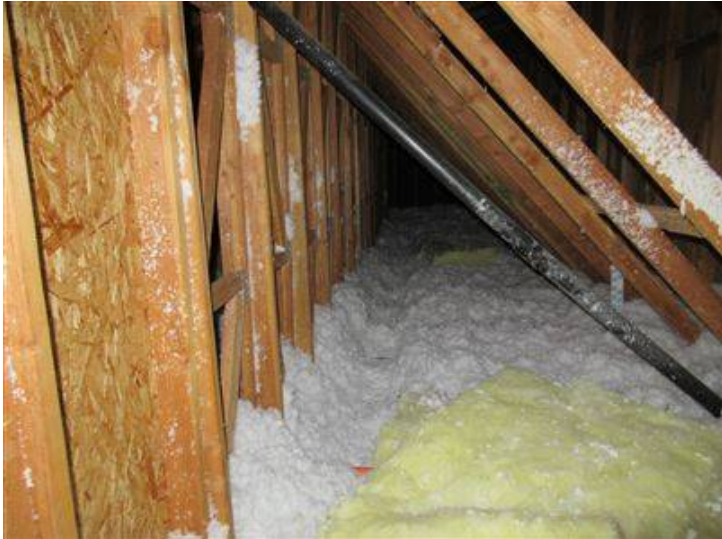
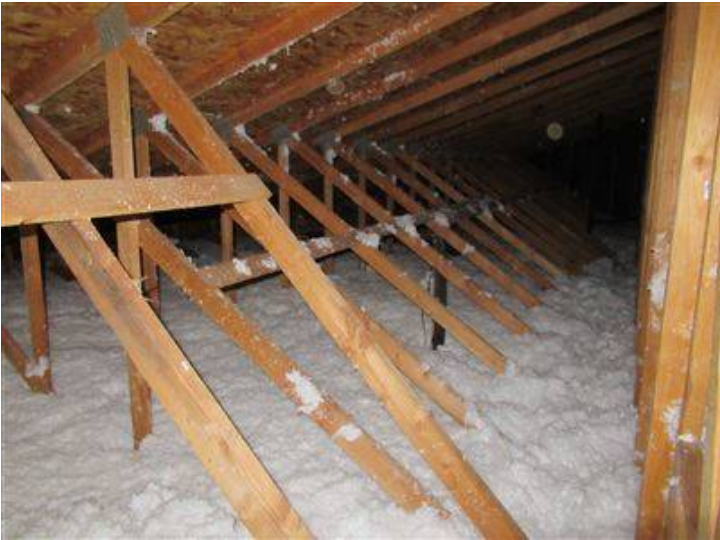
3) Attic areas traversed appeared to be in overall good condition.

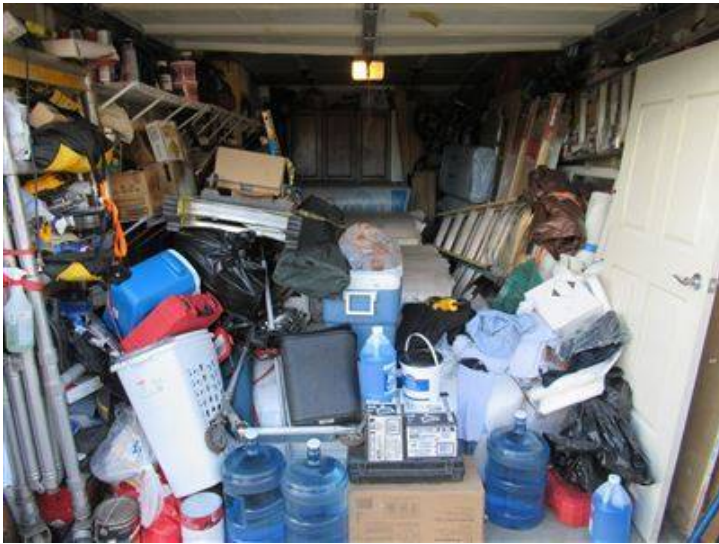
Photo 4-1

Many floor areas were obscured by stored items and couldn't be fully evaluated.

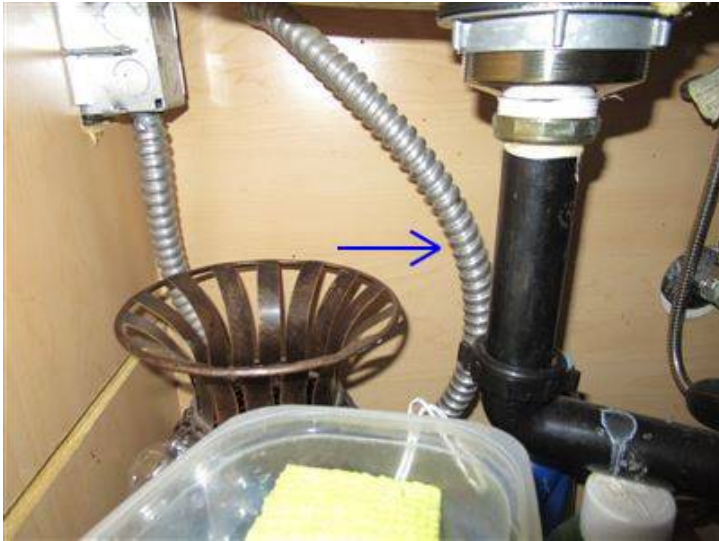
Photo 5-1
Below kitchen sink

Conduit and/or fittings at one or more locations were loose. This is a potential safety hazard for shock or fire. Recommend that a qualified electrician repair as necessary.

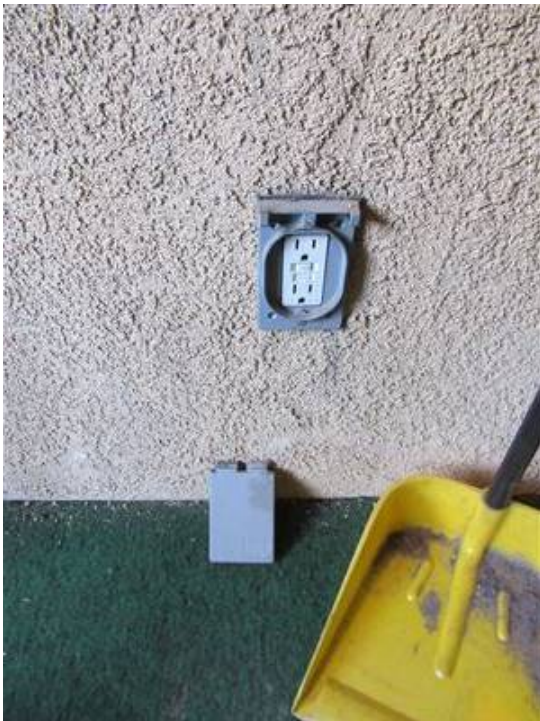
Photo 6-1

One or more cover plates installed outside were loose. This is a potential shock and/or fire hazard. Recommend that a qualified electrician repair as necessary.

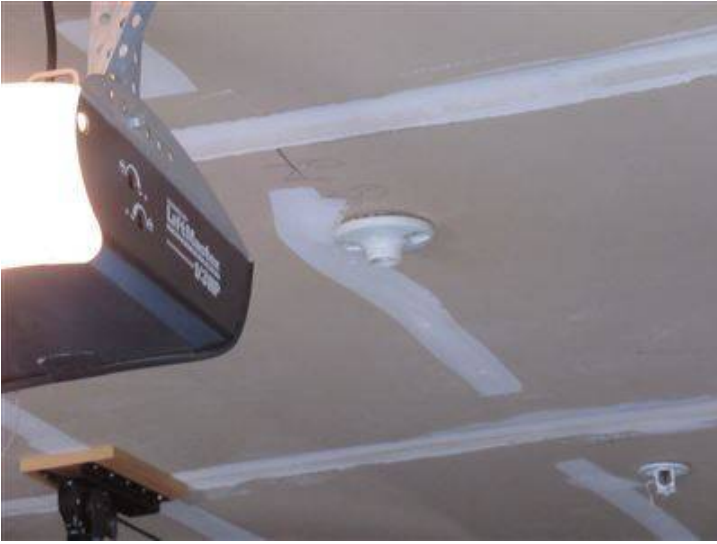
Photo 8-1
Garage

Bulbs in one or more light fixtures were missing or broken. These light fixtures couldn't be fully evaluated. If replacement bulbs are inoperable, then recommend that a qualified electrician evaluate and repair or replace light fixtures as necessary.

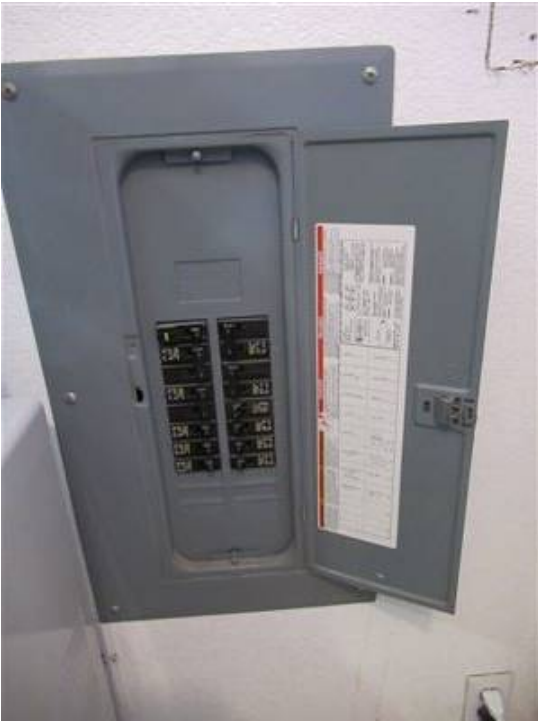
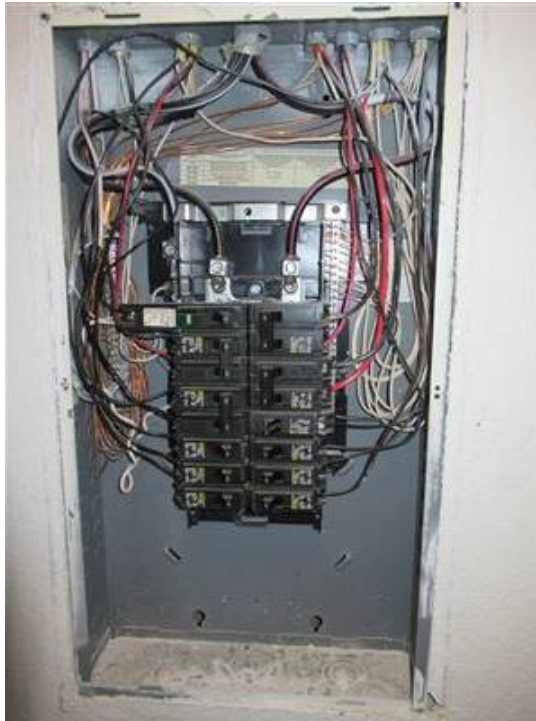
The sub-panel appeared to be in good condition.

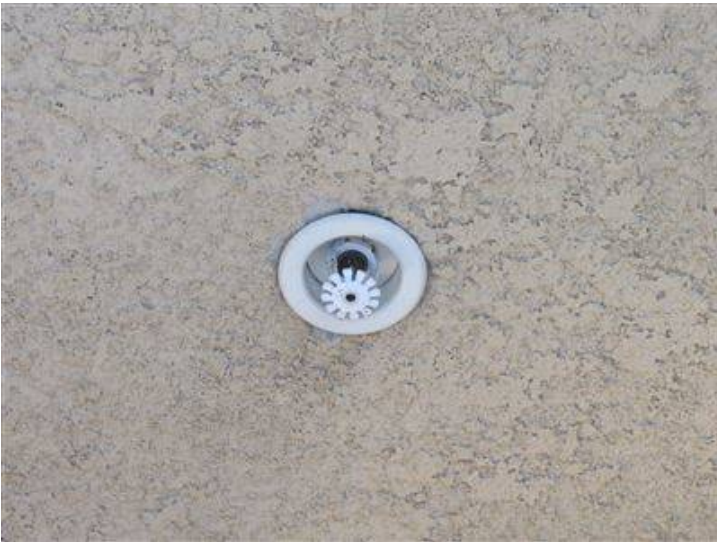
Photo 10-1

A fire suppression system was installed on the premises. These are specialty systems and are excluded from this inspection. Comments in this report related to this system are made as a courtesy only and are not meant to be a substitute for a full evaluation by a qualified specialist. These systems normally require periodic inspection by a specialist to ensure correct operation. For example, checking for possible backflow contamination of the potable water system, or correct operation of valves and gauges. Recommend that a qualified specialist inspect this system in accordance with National Fire Prevention Association (NFPA) 25 standards.

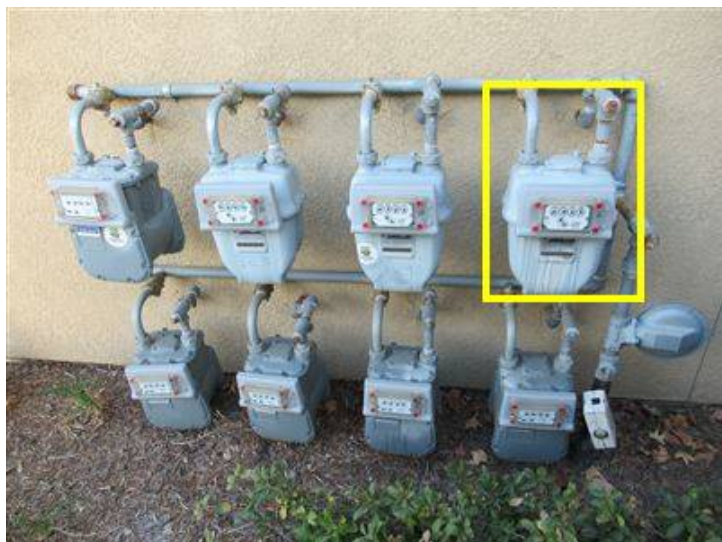
Photo 12-1

Main gas shut-off valve location.

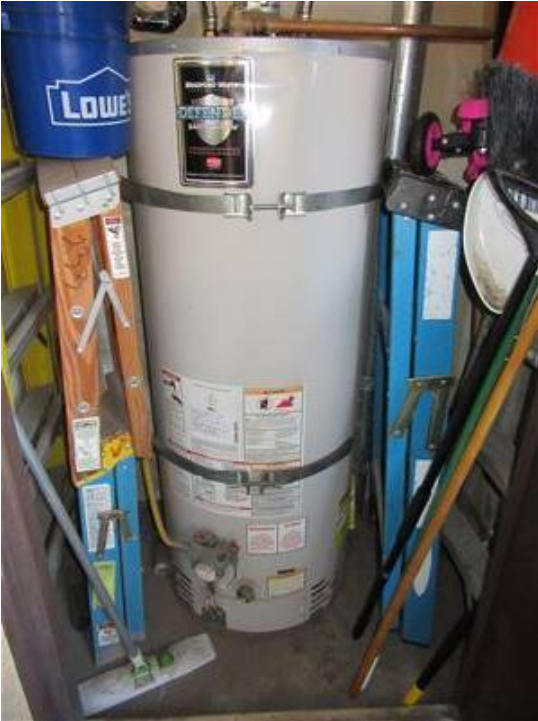
Photo 13-1

13) ✓ The water heater was serviceable.

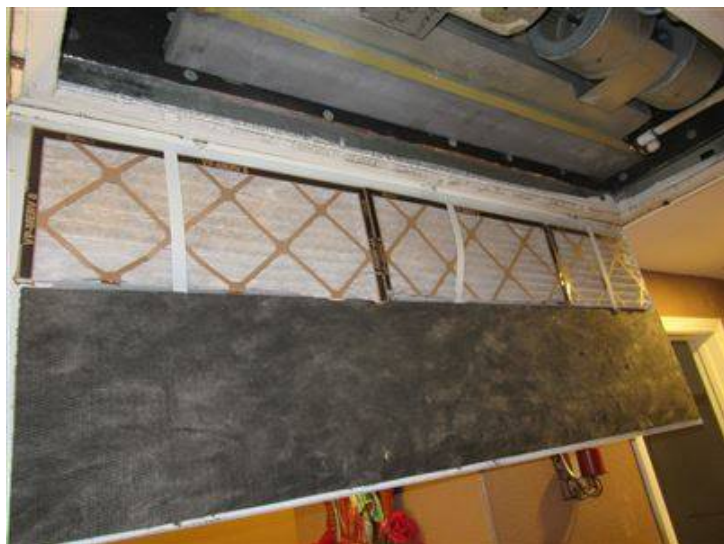
Photo 15-1

Recommend replacing or washing HVAC filters upon taking occupancy depending on the type of filters installed. Regardless of the type, recommend checking filters monthly in the future and replacing or washing them as necessary. How frequently they need replacing or washing depends on the type and quality of the filter, how the system is configured (e.g. always on vs. "Auto"), and on environmental factors (e.g. pets, smoking, frequency of house cleaning, number of occupants, the season).

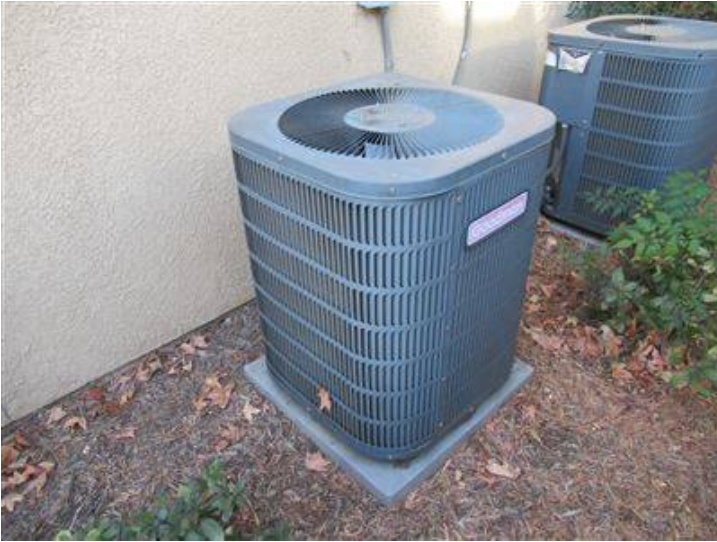
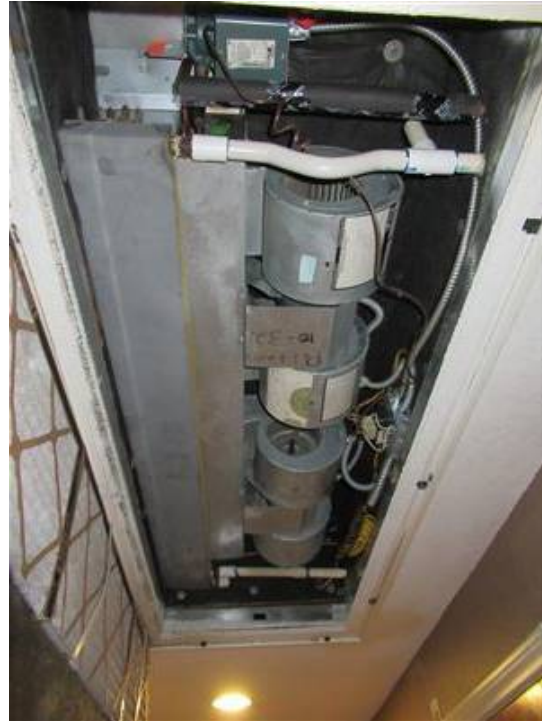
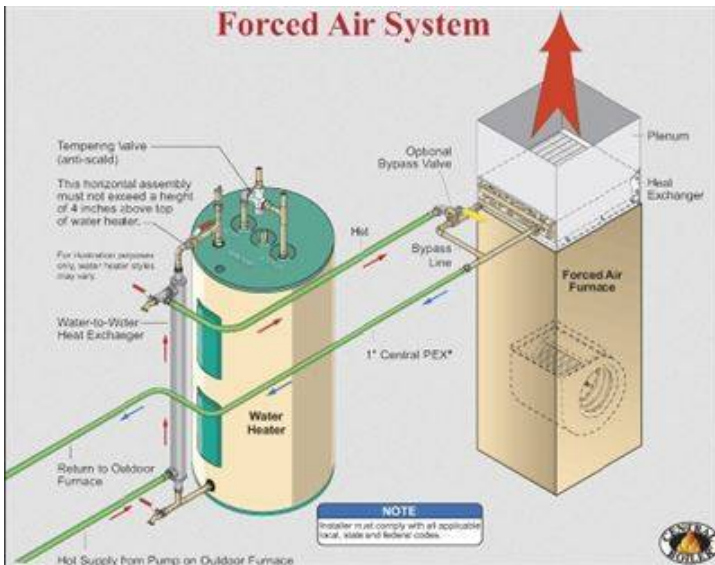
16) ✓ The heating & cooling system was serviceable at the time of inspection.

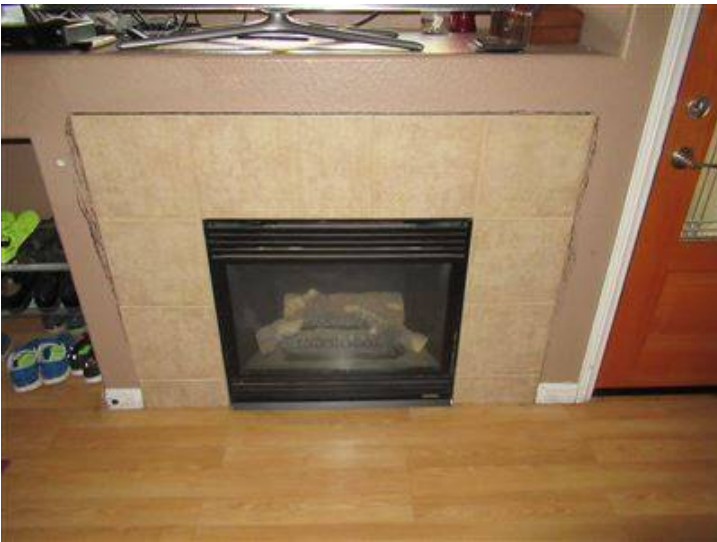
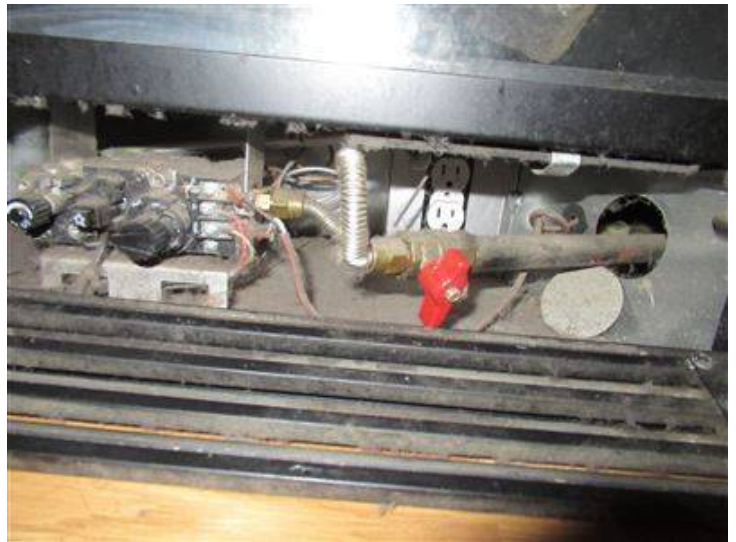
The gas fireplace or stove was not fully evaluated because the gas was turned off. The inspector only operates normal controls (e.g. on/off switch or thermostat) and does not light pilot lights or operate gas shut-off valves. Recommend that the client review all documentation for such gas appliances and familiarize themselves with the lighting procedure. If necessary, a qualified specialist should assist in lighting such appliances, and make any needed repairs.

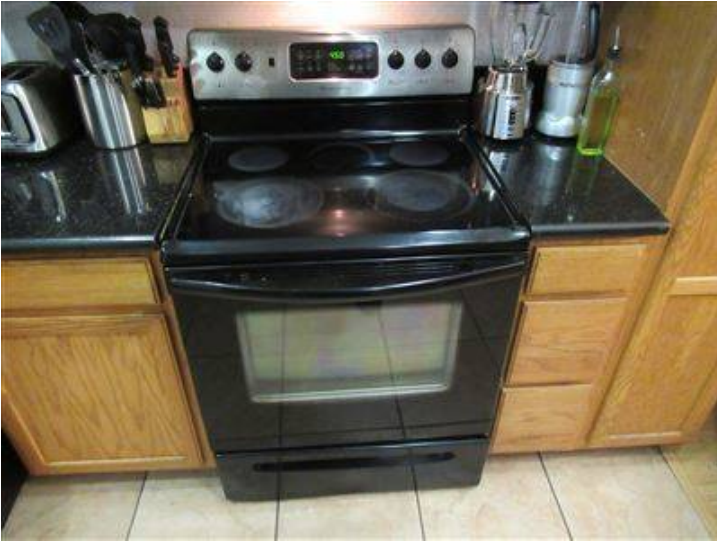
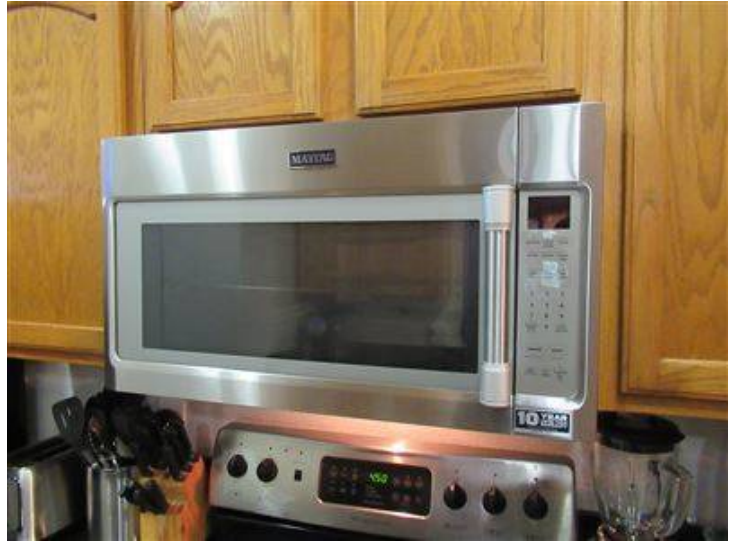
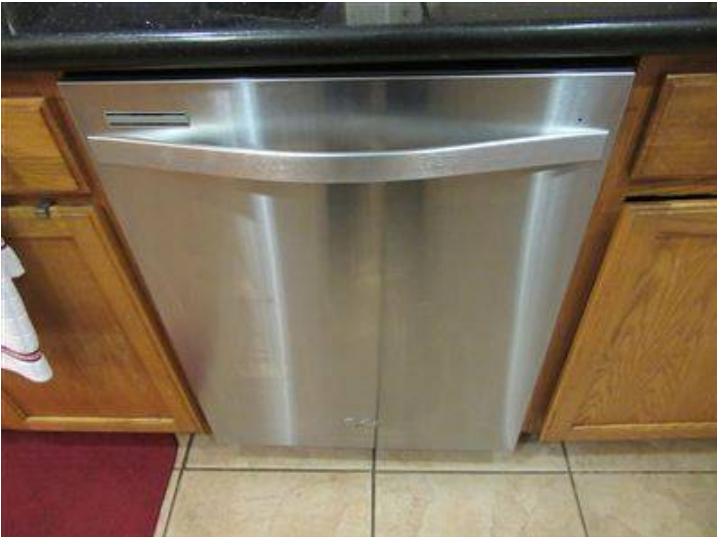
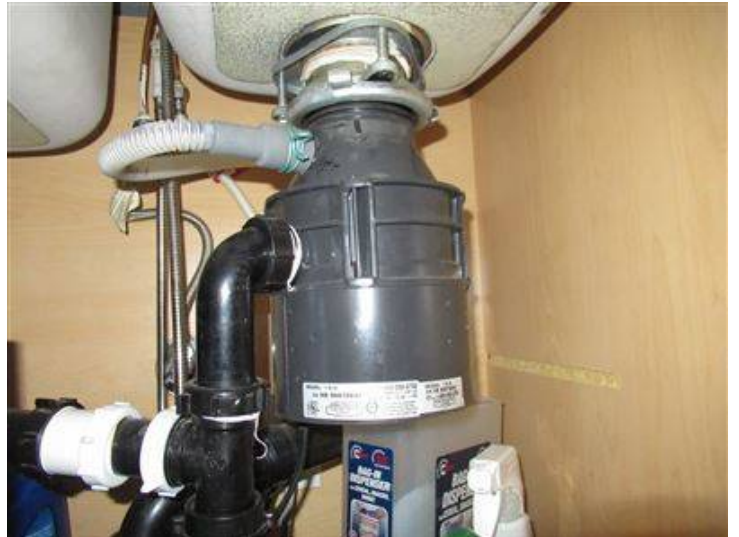
18) ✓ The following kitchen appliances were serviceable.

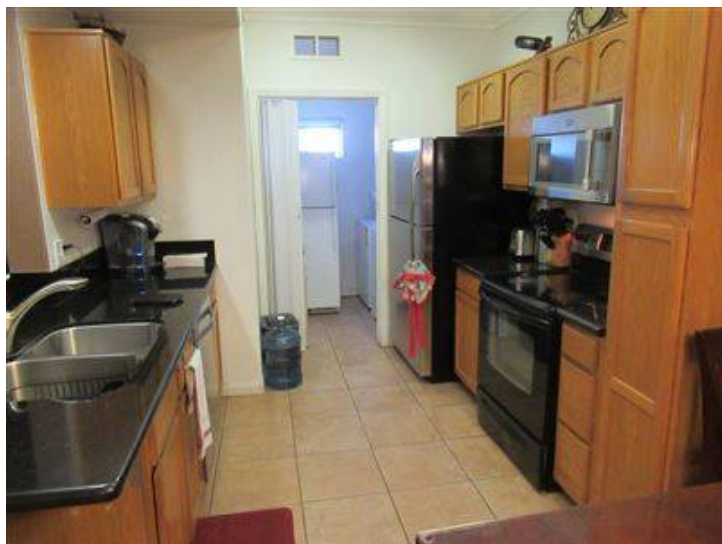
Photo 19-1

The kitchen appeared to be in overall good condition.

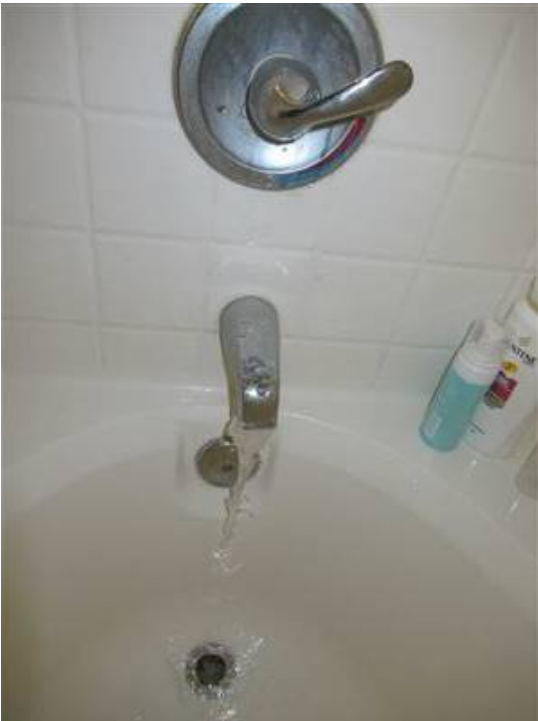
Photo 20-1

The hot water supply flow for the bathtub at location(s) #A was low or inoperable. Recommend that a qualified plumber evaluate and repair as necessary.

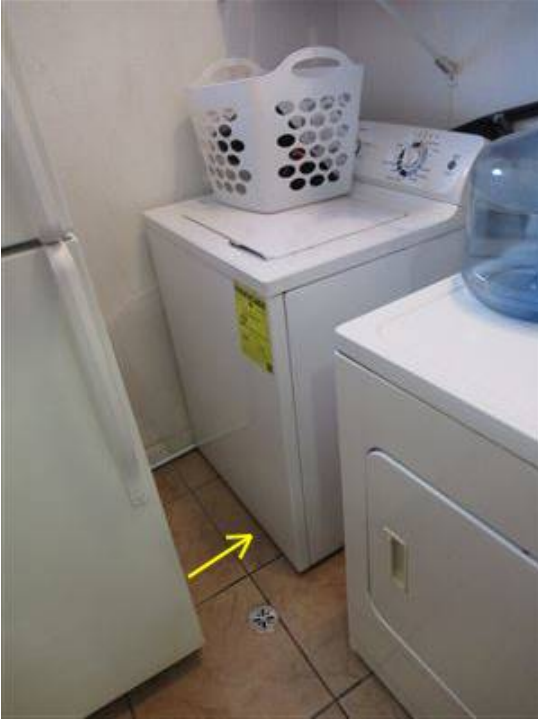
Photo 21-1

A clothes washer was installed over a finished space or in an area where leaking can cause damage, and no catch pan or drain was installed. Catch pans and drains prevent water damage to finished interior spaces below if or when the washing machine leaks, overflows or is drained. Consult with the homeowner or condo association to determine who is responsible for water damage if the washing machine leaks, overflows, or if spills occur when it's drained. If concerned, consult with a qualified contractor about installing these. Note that drain lines for catch pans may be difficult to install in an existing building unless the washer is located adjacent to an exterior wall.

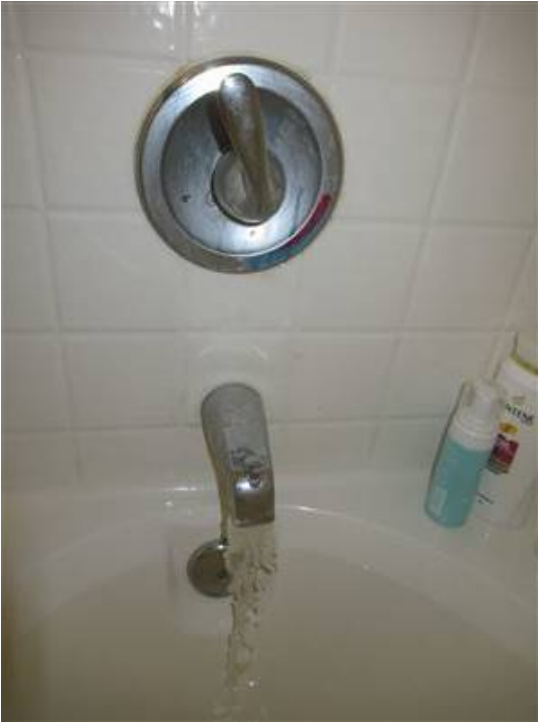
Photo 22-1

The hot and cold water supplies appeared to be reversed at the bathtub at location(s) #A. Normally, cold water is controlled by the right faucet handle and hot by the left. For mixing faucets, cold is supplied with the handle to the right and hot when the handle is to the left, or as indicated by the faucet's markings. At a minimum this is an inconvenience, but it can also result in accidental scalding. Recommend that a qualified plumber repair as necessary.

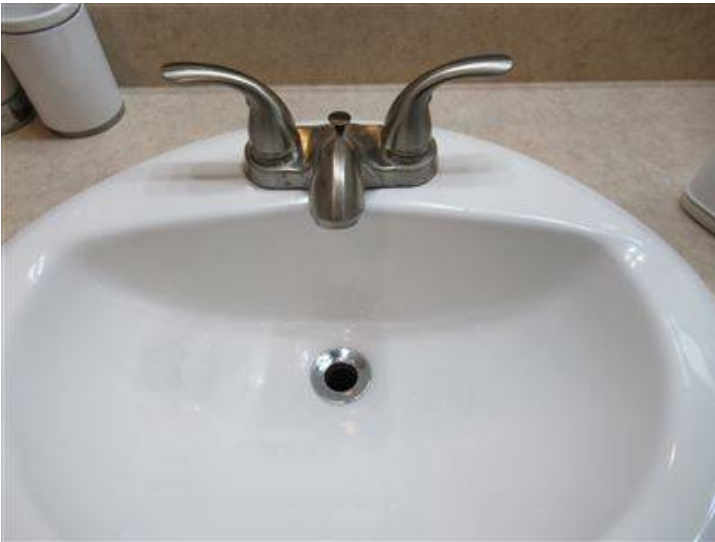
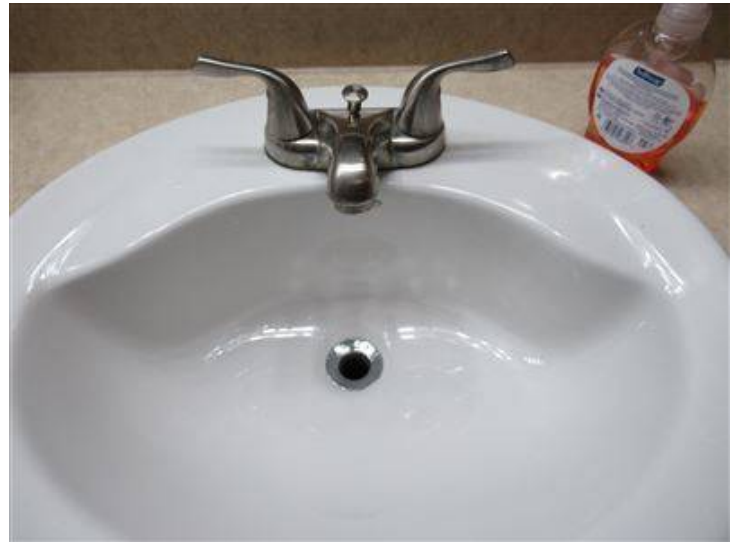
The sink drain stopper mechanism at location(s) #A and B was missing. Recommend that a qualified person repair or replace as necessary.

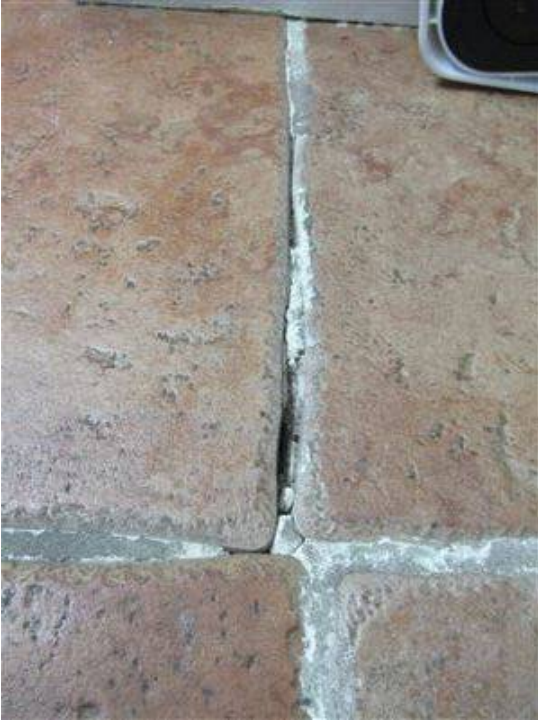
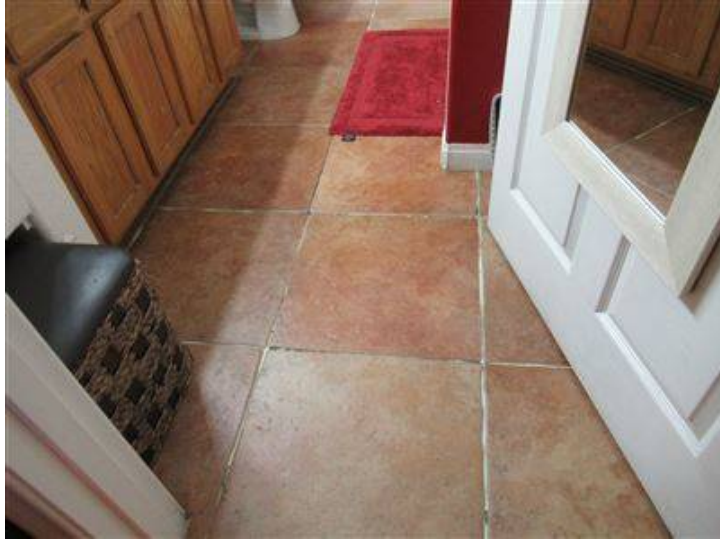
24) 🛠️ Recommend cleaning and sealing the grout in flooring at location(s) #B now and in the future as necessary to prevent staining and to improve waterproofing.

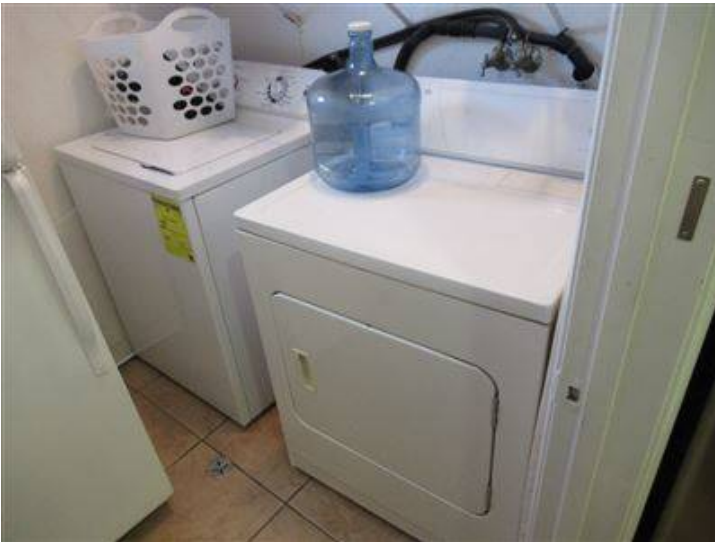
Photo 25-1

25) ⓘ No access or only limited access was available to the back of the clothes washer and dryer, and to utility hook-ups located behind the appliances. The inspector normally attempts to determine the presence of a gas vs. electric power supply, the configuration of the stand pipe, whether the dryer exhaust duct is serviceable, etc. Because of the lack of access, the inspector was unable to fully evaluate and/or describe the hook-ups and appliances.

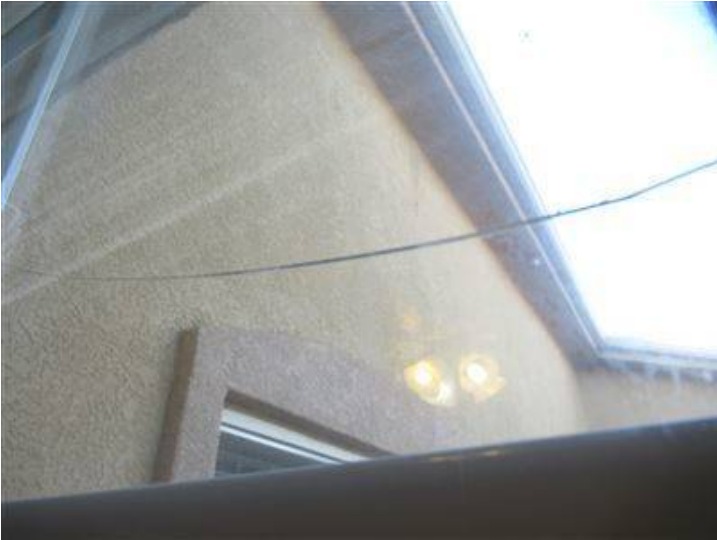
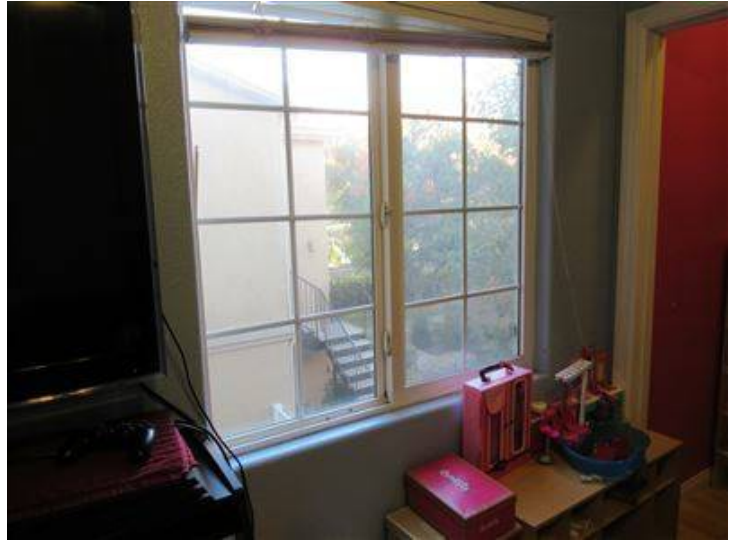
Glass in one or more windows was cracked, broken and/or missing. Recommend that a qualified contractor replace glass where necessary.

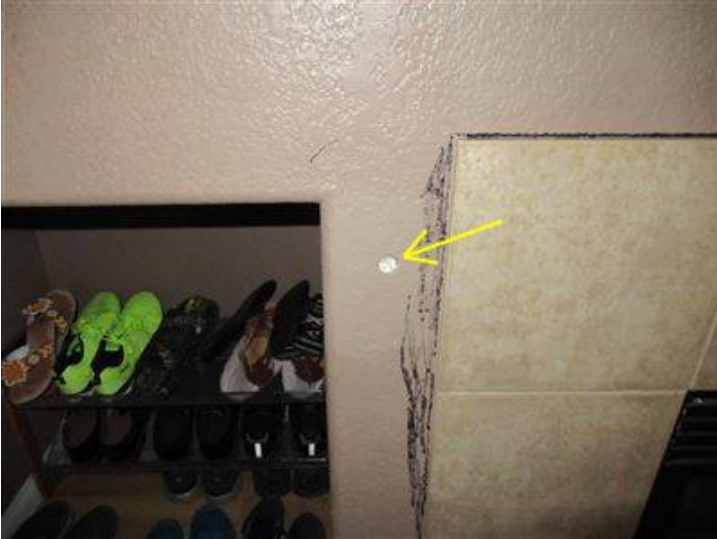
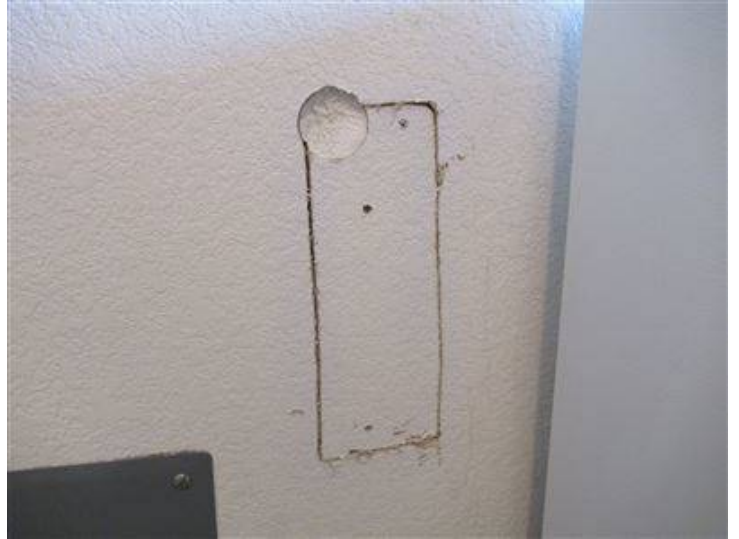
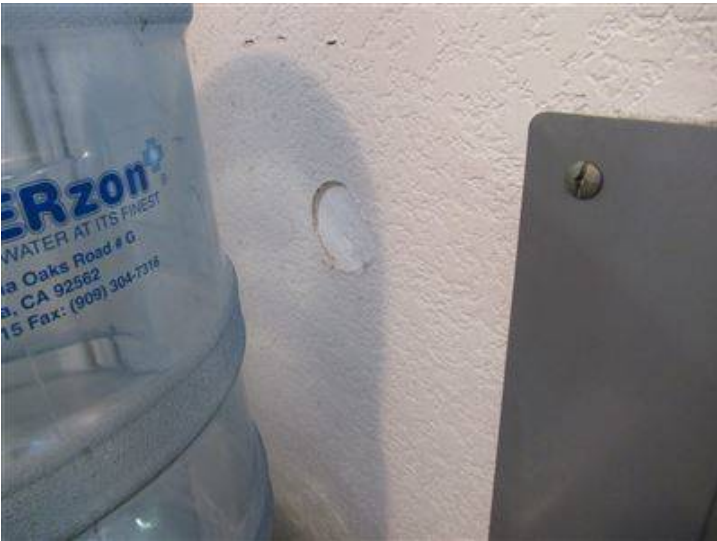
One or more walls were damaged and/or had substandard repairs. Recommend that a qualified person repair as necessary.

Photo 27-1
Next to fireplace

Photo 27-2
Laundry room

Photo 27-3
Laundry room
